Protecting Masonry Materials and Walls During Construction

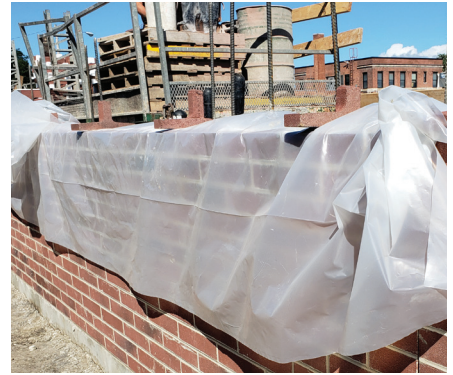
At the end of the workday, and after completing each segment of the masonry wall, the top surface of the masonry must be protected to prevent water penetration. Use a plastic tarp to cover the unfinished masonry work to protect it from the weather. Cap the walls as soon as possible after building them. Uncovered masonry walls are vulnerable to large quantities of water entering the wall during rainstorms, which can lead to the formation of efflorescence – especially if the wall does not have a proper flashing and weep system installed. This advice also applies to uncapped columns or other details.

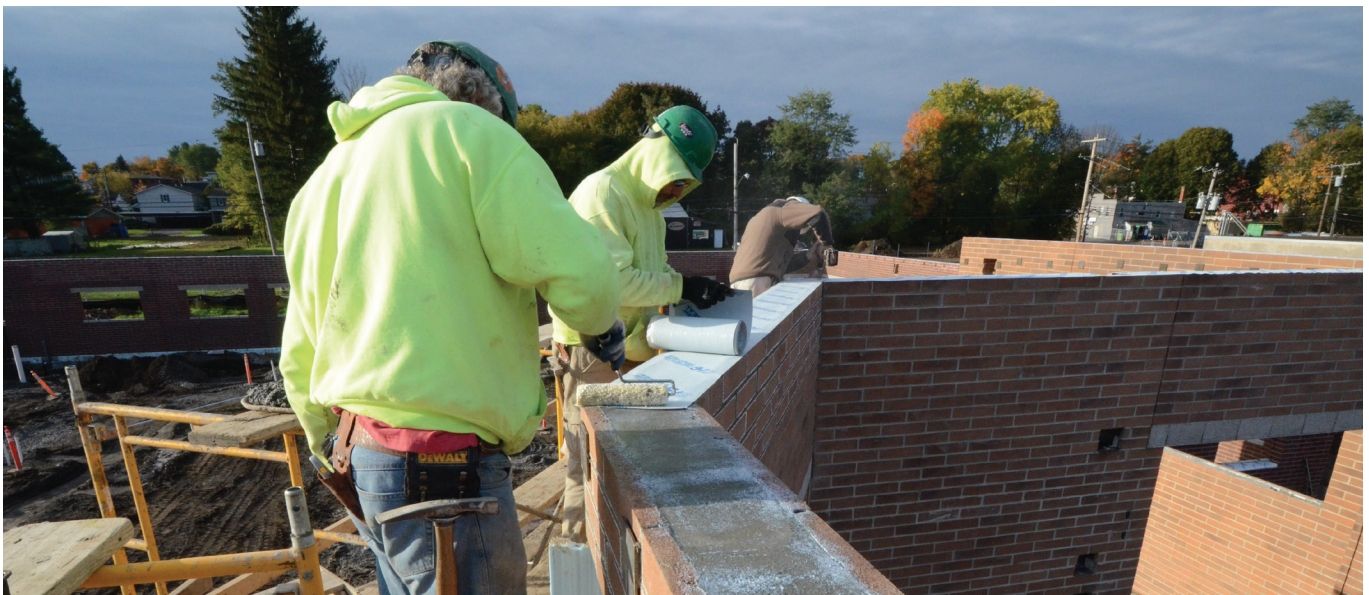
Adhering a water resistive membrane to the top of the wall – this can be left in place when the roof is installed

One effective and simple way to ensure that completed walls remain covered after the mason has left the project, is to install an inexpensive membrane at the top of the wall upon completion. Flexible flashing materials such as EPDM are inexpensive, can be glued to the top of the wall and left in place below the blocking when the permanent coping is installed. Bolts and embeds should be sealed to ensure moisture cannot enter the wall from the top. This simple step can prevent the majority of problems mason contractors typically encounter due to moisture related staining from uncovered walls.

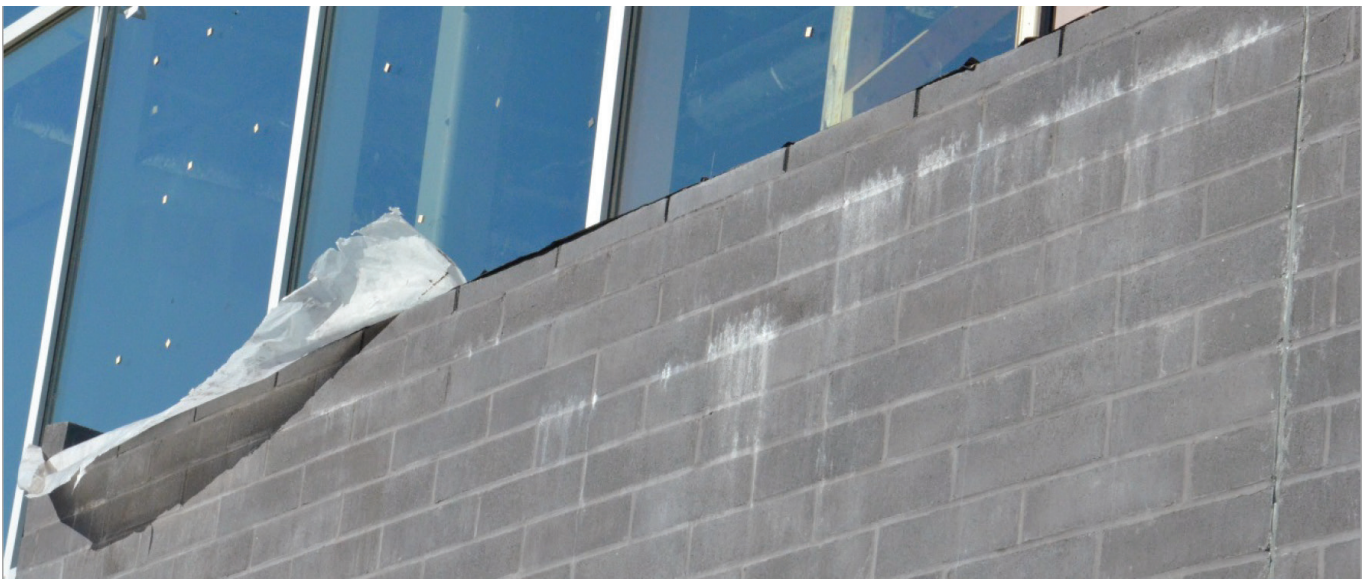
*Top of wall protection partially removed by roof contractor prior to permanent coping installation
- note efflorescence formation*

The time between when the mason finishes installing the wall and when the roofing contractor permanently caps the wall is a period when staining problems occur most often. While it is required by code that the top of walls be protected from moisture entering until the permanent coping is in place, failing to protect the top of wall at this time has resulted in the most severe moisture related staining of the masonry.
